# **INDOOR AIR QUALITY REASSESSMENT**

**District Court of Southern Norfolk County  
(Stoughton District Court)  
1288 Central Street  
Stoughton, Massachusetts**

Prepared by:  
Massachusetts Department of Public Health  
Bureau of Environmental Health Assessment  
October 2002

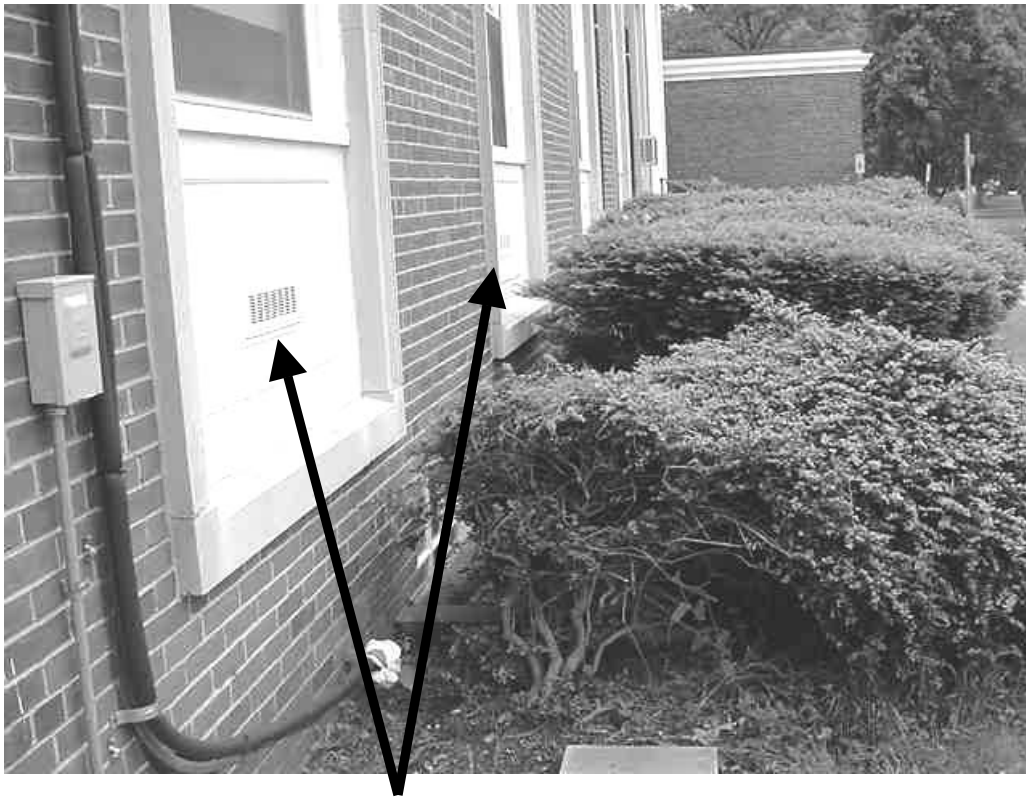
**Picture 1**

4. Shrubbery exists in close proximity to the foundation walls (see Picture 1). The growth of roots against the exterior walls can bring moisture in contact with wall brick and eventually lead to cracks and/or fissures in the foundation below ground

**Univent Air Intakes**

12. Ensure that all subterranean pit drains are cleaned and fully functional.
13. Move foliage to a distance of at least five feet away from the foundation.

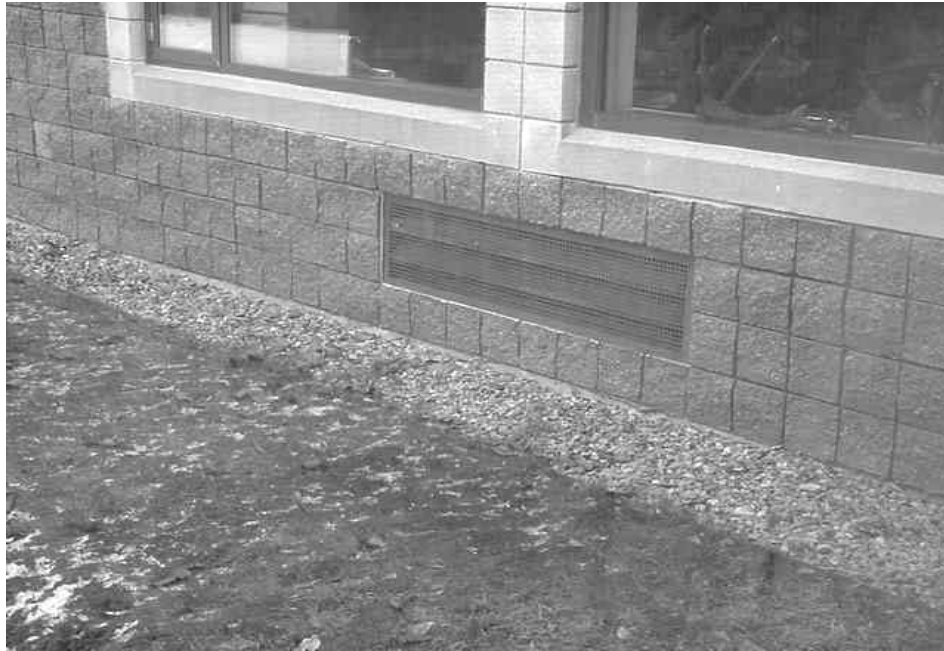
**Picture 1A**

**Univent Fresh Air Intake At The Berkley Community School, Berkley, MA  
(Compare The Size Of The Grille In This Picture Compared To The Windows, Then Compare To  
Picture 1)**

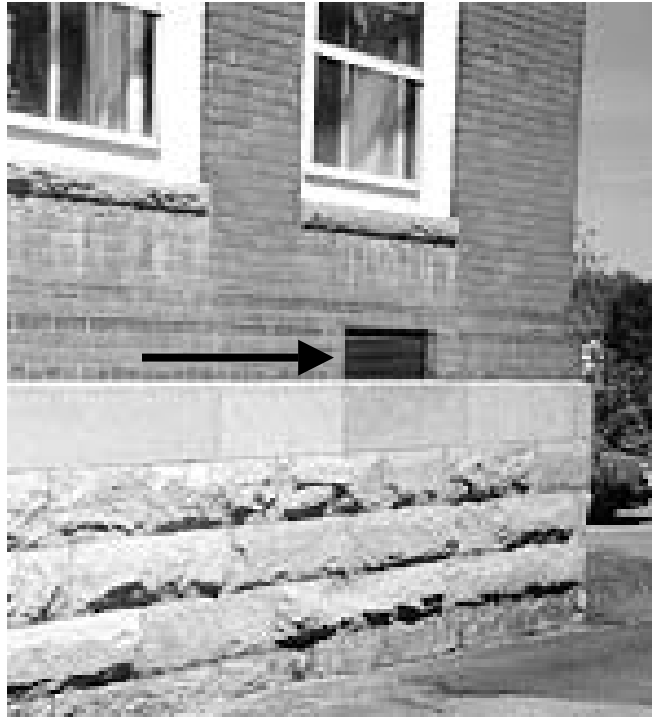
**Picture 1B**

**Univent Fresh Air Intake At The South Berkshire District Court, Great Barrington, MA  
(Compare The Size Of The Grille In This Picture Compared To The Windows, Then Compare To  
Picture 1)**

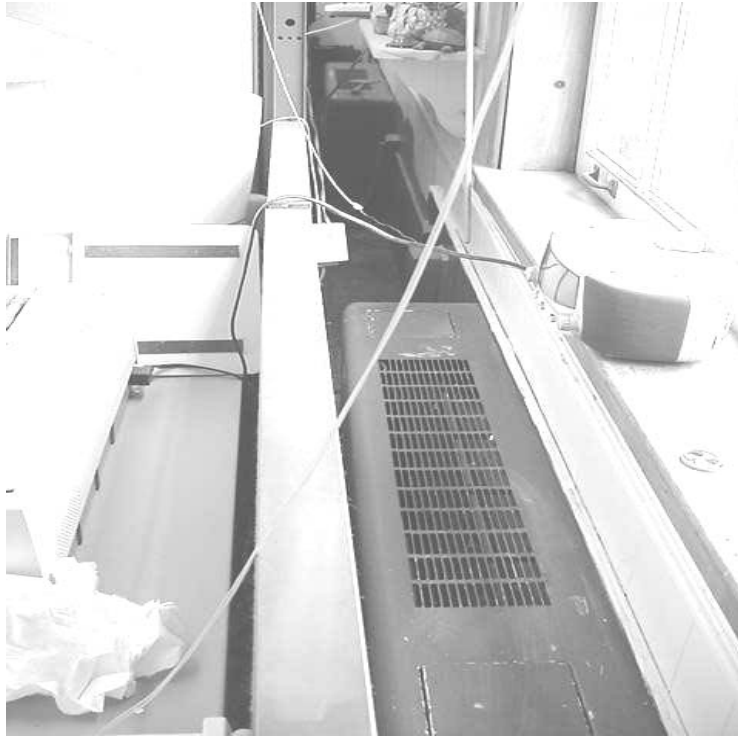
**Picture 2**

**Univents In Civil/Small Claims Area Obstructed By Cloth Partitions**

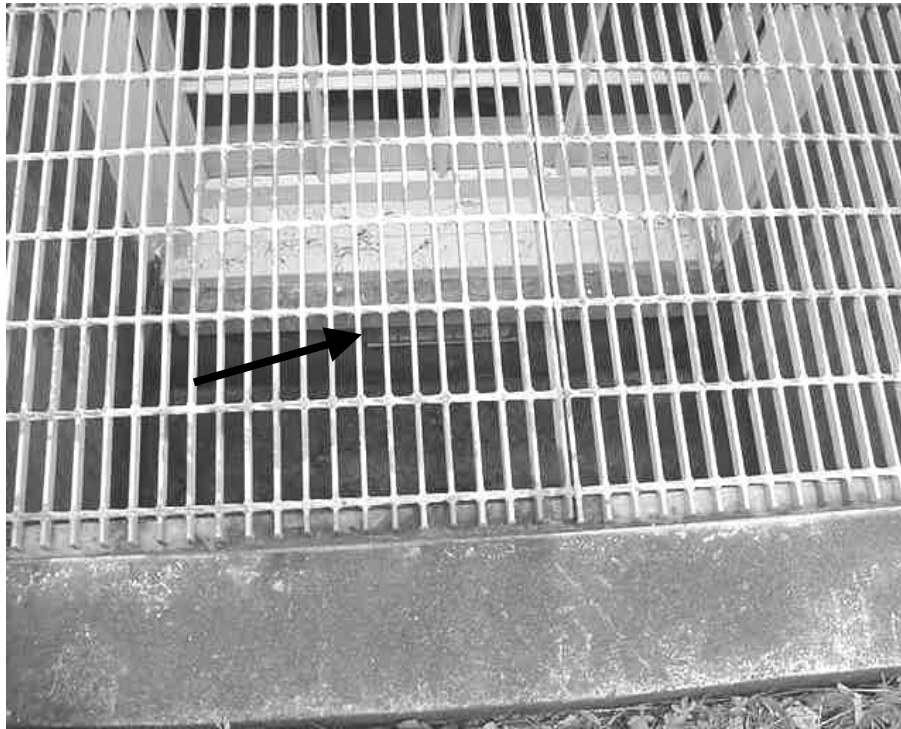
**Picture 3**

2. The fresh air intake for the univent in this area is located near the bottom of a subterranean cement lined pit (see Picture 3). While a drain exists in the floor of the pit, the cements walls appeared to be moistened. Operation of the univent can draw water vapor from this pit.

**Univent Fresh Air Intake Located Near The Bottom Of A Subterranean, Cement Lined Pit**

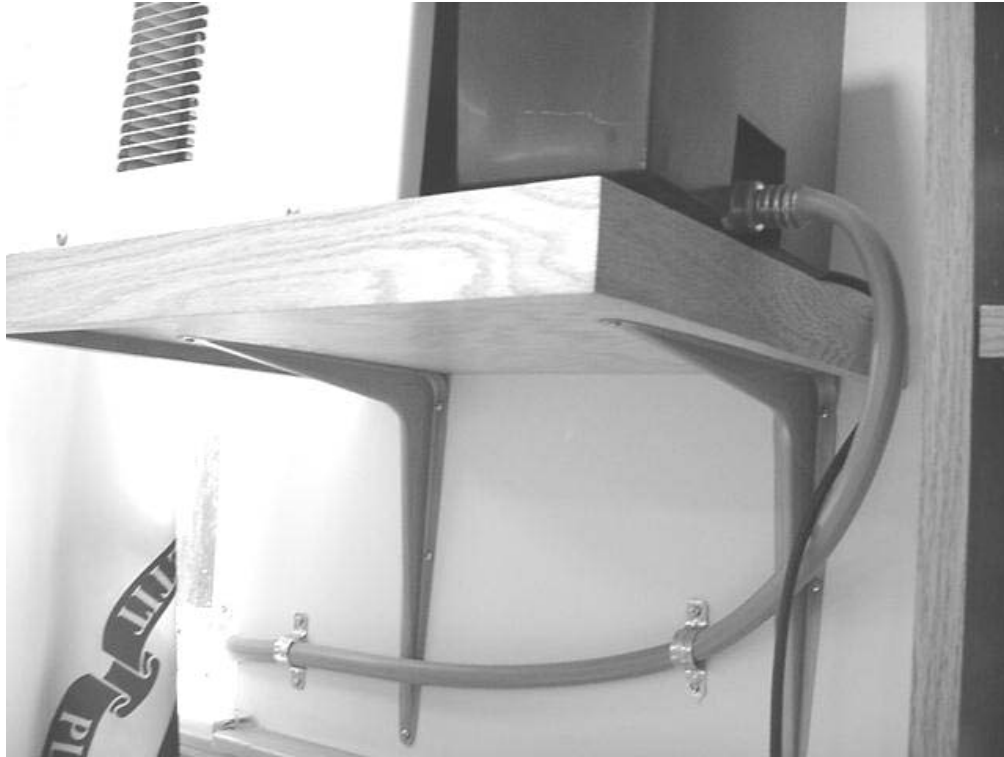
**Picture 4**

Dehumidifiers were being operated in a number of areas in the basement (e.g., the DA's Office). Normally dehumidifiers are equipped with reservoirs to collect water, which should be emptied and cleaned as per the manufacturer's instructions to prevent bacterial and mold growth. Dehumidifiers in the building were equipped with drainage hoses that emptied directly outside the building (see Picture 4). However, the outlet for the hose sits over an inch from the base of the reservoir, which prevents water from completely draining. Standing water can become stagnant and provide a source of unpleasant odors and microbial growth. Standing water was observed in the dehumidifier in the conference room adjacent to room 28. In addition, the dehumidifier hose shown in Picture 5 is crimped which can prevent proper drainage and lead to microbial growth within the hose.

**Dehumidifier In Basement Office With Hose Draining To The Outside Of The Building**

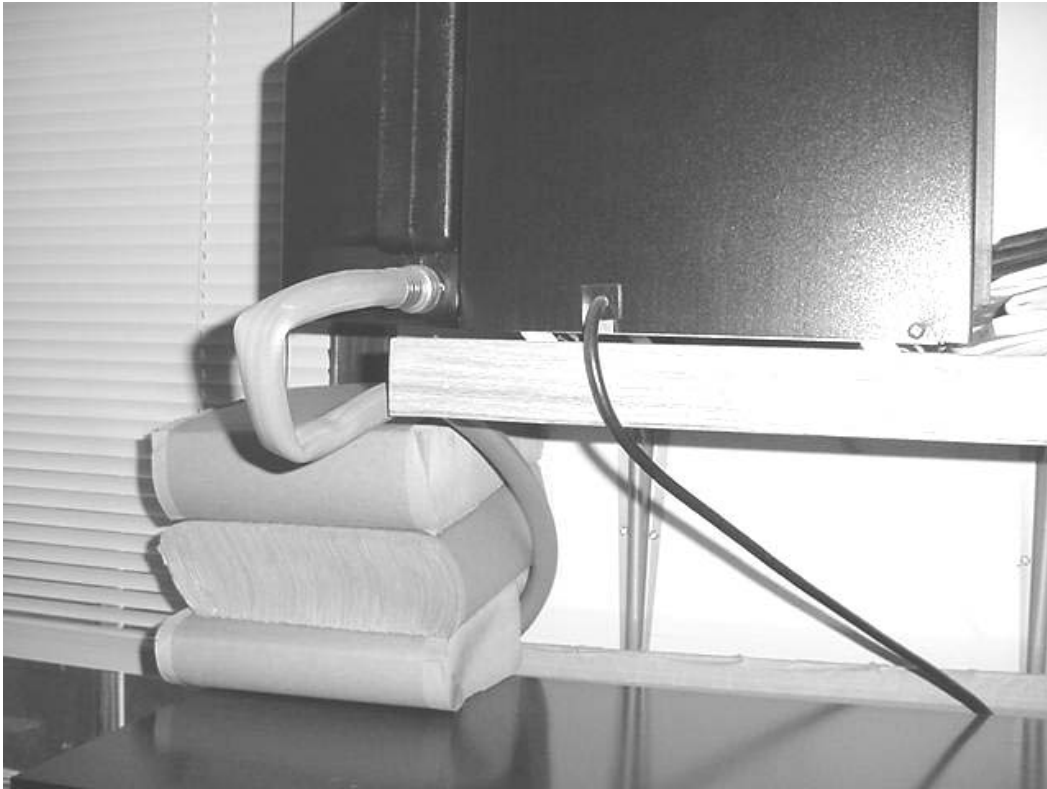
**Picture 5**

**Dehumidifier In Basement Office With “Kinked” Hose ”Preventing Proper Drainage**

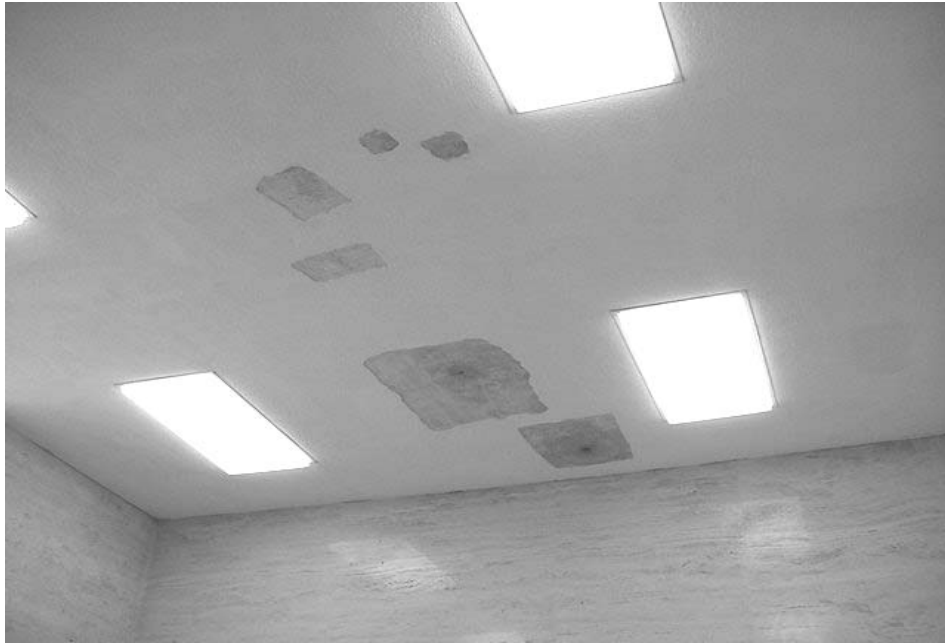
**Picture 6**

Water damaged building materials were observed in some areas, (most notably the main foyer (see Pictures 6 & 7)) are evidence of roof and/or plumbing leaks. Active/repeated areas of roof leaks were reported by occupants in the main foyer and in the hallway outside of room 12. Water-damaged building materials can provide mediums for microbial growth and should be replaced after a water leak is discovered.

**Water Damaged Ceiling Plaster In Main Foyer**

1. Repair leaking roof. Once roof is repaired, replace any remaining water-stained ceiling tiles and other water damaged building materials. Examine the area above and around these areas for microbial growth. Disinfect areas of water leaks with an appropriate antimicrobial.

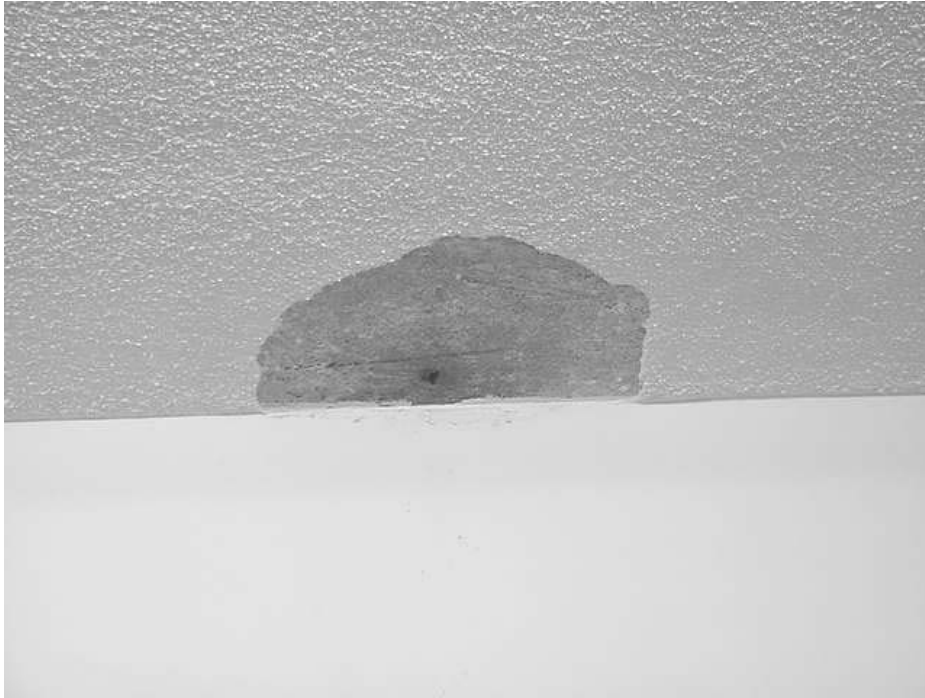
**Picture 7**

**Close-Up Of Water Damaged Ceiling Plaster**

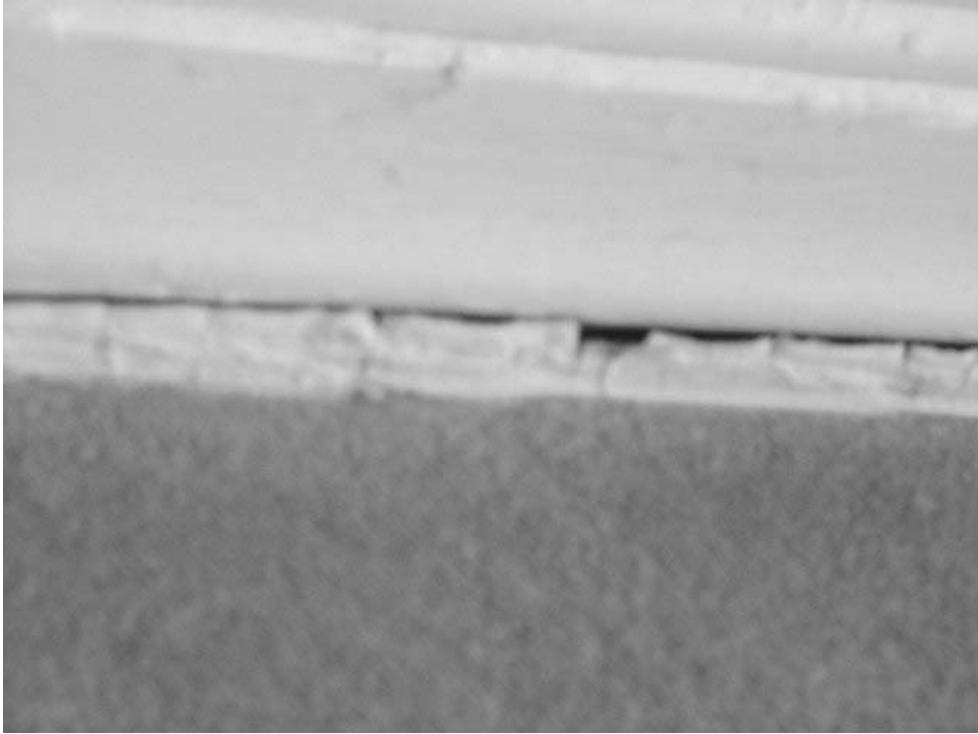
**Picture 8**

Missing/damaged exterior caulking was noted around windows and wall panels (see Picture 8). Water penetration through window frames can lead to mold growth under certain conditions. Repairs of window leaks are necessary to prevent further water penetration. Repeated water damage can result in mold colonization of window frames, porous building materials and items stored on or near windowsills.

**Missing/Damaged Caulking Around Exterior Wall Panel/Window Bank**

5. Repair/replace missing or damaged window caulking building-wide to prevent water penetration through window frames.

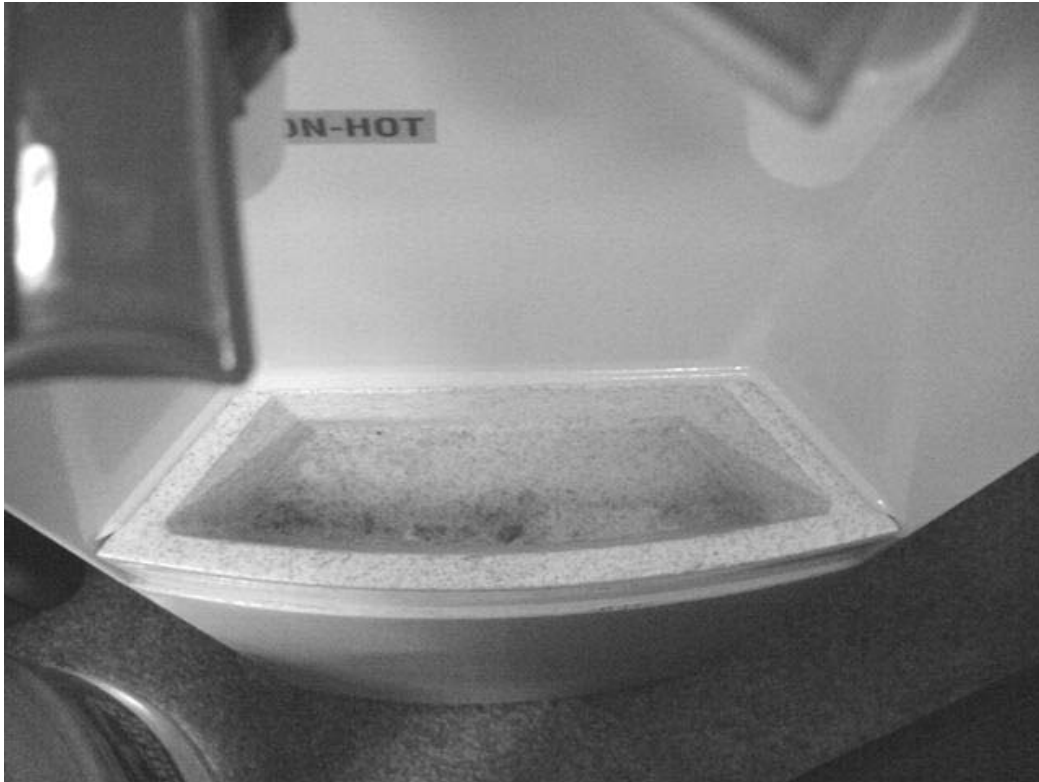
**Picture 9**

Several areas had water coolers installed over carpeting. Water spillage or overflow of cooler catch basins can result in the wetting of the carpet. Residue/build-up in the reservoirs of water coolers was also observed (see Pictures 9). The reservoirs of water coolers are also designed to catch excess water during operation and should be emptied/cleaned regularly to prevent microbial and/or bacterial growth.

**Debris/Mold Growth In Water Cooler Catch Basin**

17. Consider placing a water impermeable barrier beneath water coolers and fountains to prevent moistening of carpets.
18. Replace missing ceiling tiles and fill utility holes, to prevent the egress of dirt, dust and particulate matter into classrooms.

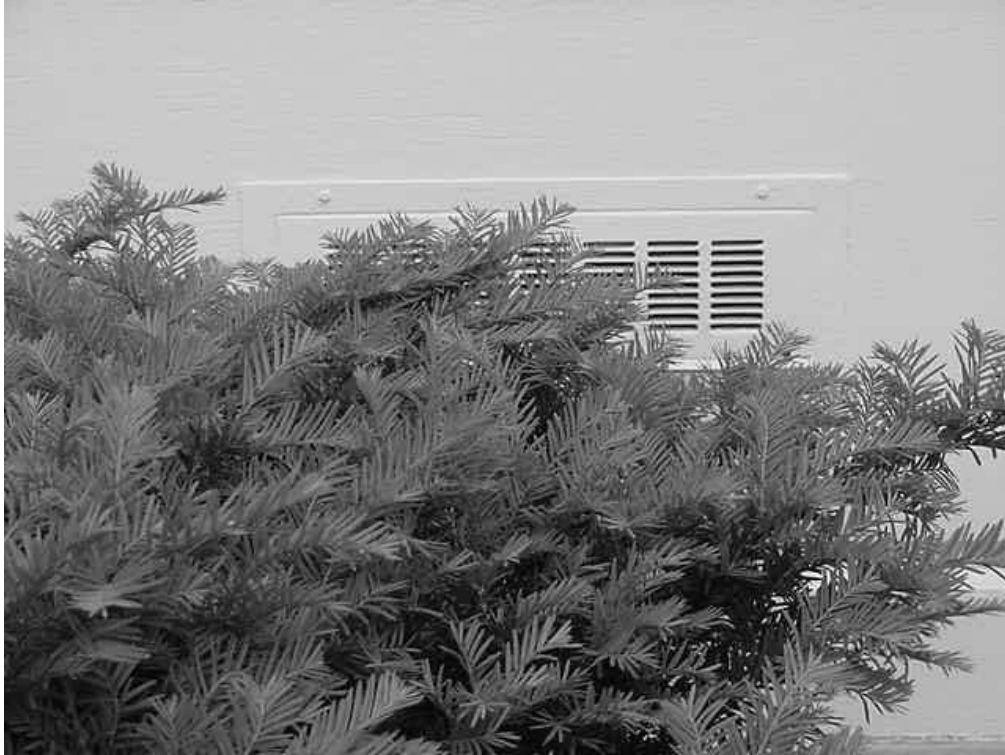
**Picture 10**

Along the front of the building, shrubbery and plants were in close proximity to univent fresh air intakes (see Picture 10). Shrubby and plants can be a source of mold and pollen and should be placed and/or maintained to ensure that fresh air intakes remain clear of obstructions.

**Shrubbery Obstructing Univent Air Intake**

15. Trim plant growth away from air intakes to avoid the entrainment of moisture, pollen and mold.
16. Install backflow preventer on the sewer line to prevent further backups.

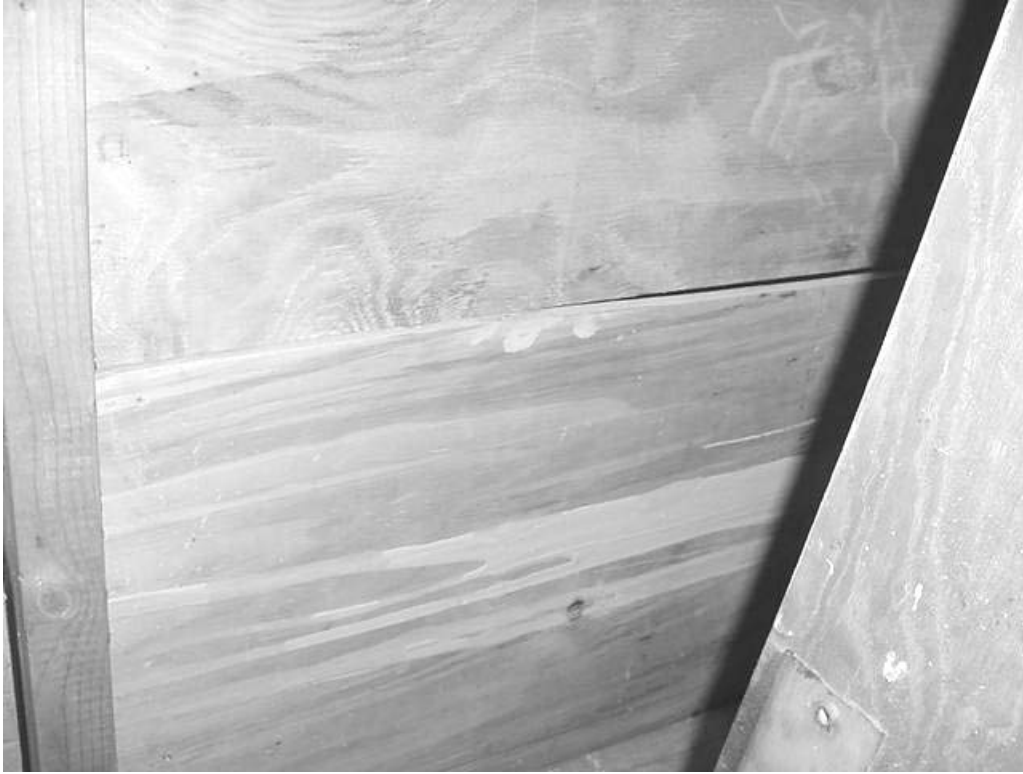
**Picture 11**

Several conditions that can potentially affect indoor air quality were also identified. Construction of an elevator shaft was on-going during the BEHA assessment. Containment walls of plywood were erected and sealed with duct tape in some areas (see Pictures 11 & 12). BEHA staff observed spaces around containment walls through which light could be seen penetrating. Containment barriers should be as airtight as possible to prevent the migration of dust, odors and other renovation generated pollutants. Recommendations specifically regarding renovation of occupied buildings are included in the Renovations/Construction section of this report.

**Interior Shot Of Plywood Containment Wall, Note Spaces Between Panels**

8. Seal utility holes, spaces in floor decking and temporary walls to eliminate pollutant paths of migration. Seal holes created by missing tiles in ceiling temporarily to prevent renovation pollutant migration.

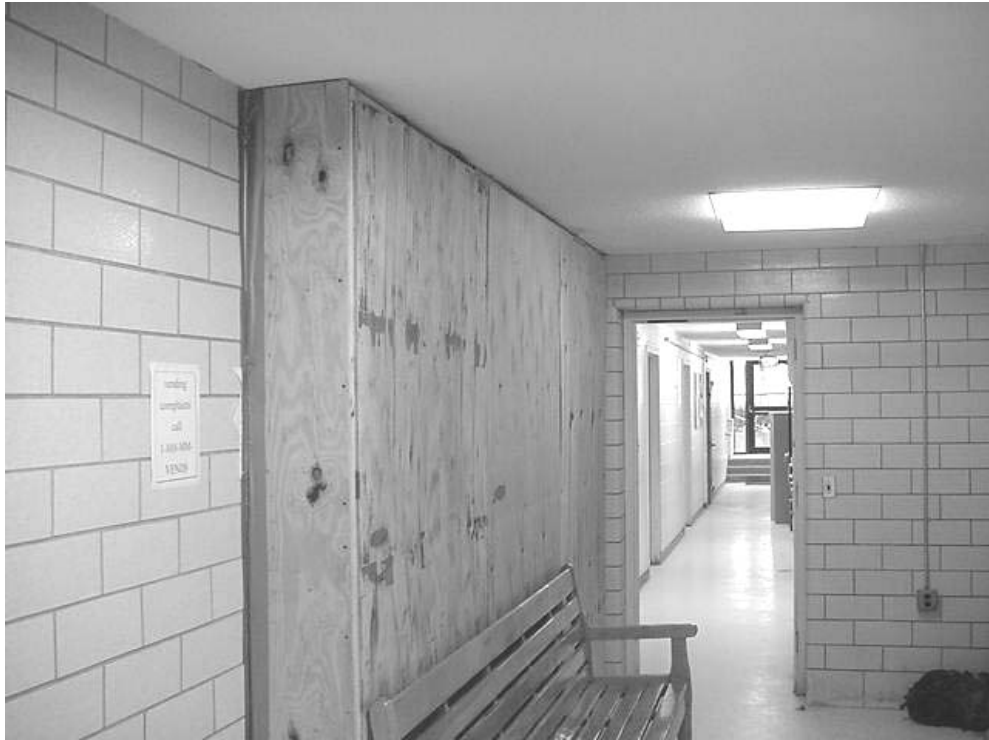
**Picture 12**

**Occupied Side Of Plywood Containment Wall, Note Spaces Along Side Of Barrier Sealed With Duct Tape; Along The Top Is Not**

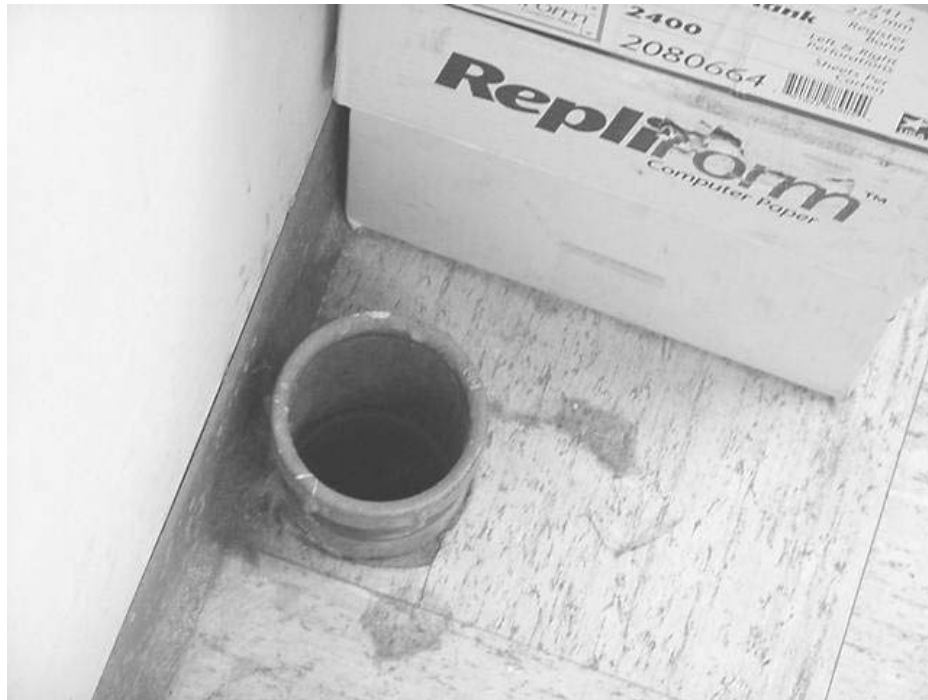
**Picture 13**

Missing/damaged ceiling tiles and open utility holes were seen in the basement hallway and in the civil/small claims area (see Picture 13). Missing ceiling tiles and open utility holes can provide a means of egress for odors, fumes, dusts and vapors between

**Open Utility Hole In Civil/Small Claims Area**

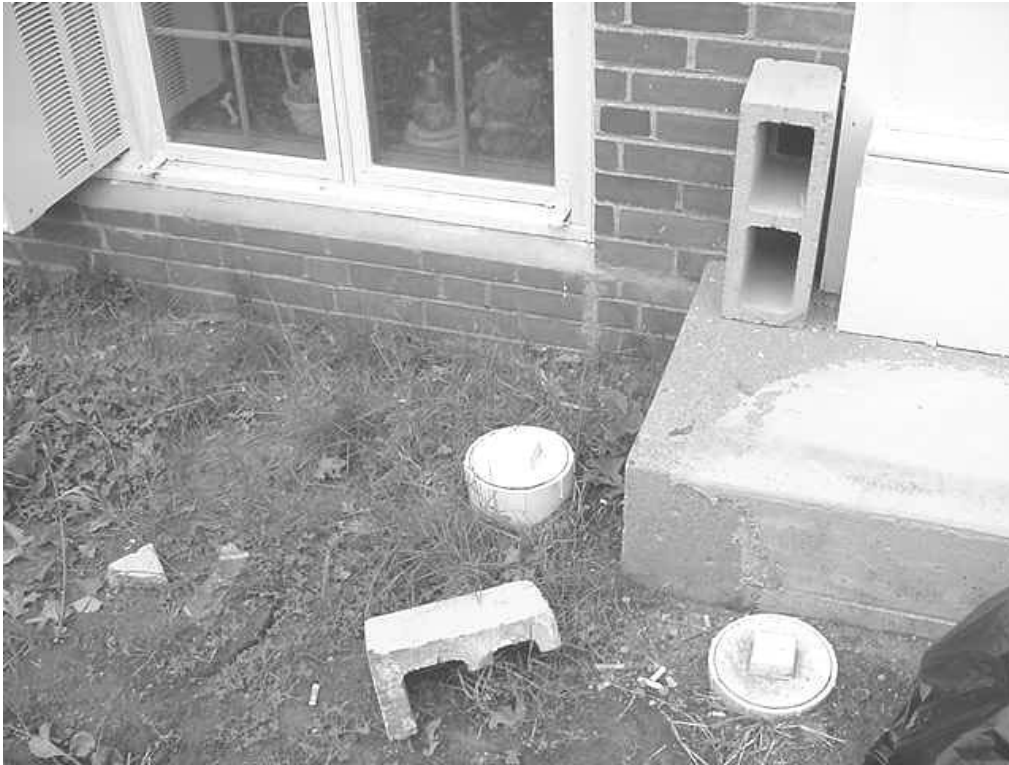
**Picture 14**

Periodic sewer gas odors were reported by basement occupants. Odors were believed to be from a recently installed plumbing fixture located outside this area (see Picture 14). Another possible contributing source of odors is the univents. It appears that the original installation of the univent system was to include air conditioning. This conclusion is derived from the fact that each univent is equipped with a hard-plumbed condensation drain system (see Picture 15). The purpose of this type of drainage system is to remove water as it drips from the coils when the system operates in the cooling mode in warm weather. Since the HVAC system does not provide air conditioning, condensation is not drained by this system. Further, no traps were observed in univent condensation drainpipes (see Picture 15). Drains are usually designed with traps in order to prevent sewer odors/gases from penetrating into occupied spaces. When water enters a drain, the trap fills and forms a watertight seal. Without periodic input of water (e.g., every other day), traps can dry, preventing a watertight seal. Without traps, odors and other material can travel up the drain and enter occupied spaces. Sewer gas can be irritating to the eyes, nose and throat of some individuals. No sewer gas odors were detected during the BEHA assessment. Since these drain pans do not collect condensation, the drains should be sealed.

**Plumbing Fixture Outside Of Probation Offices**

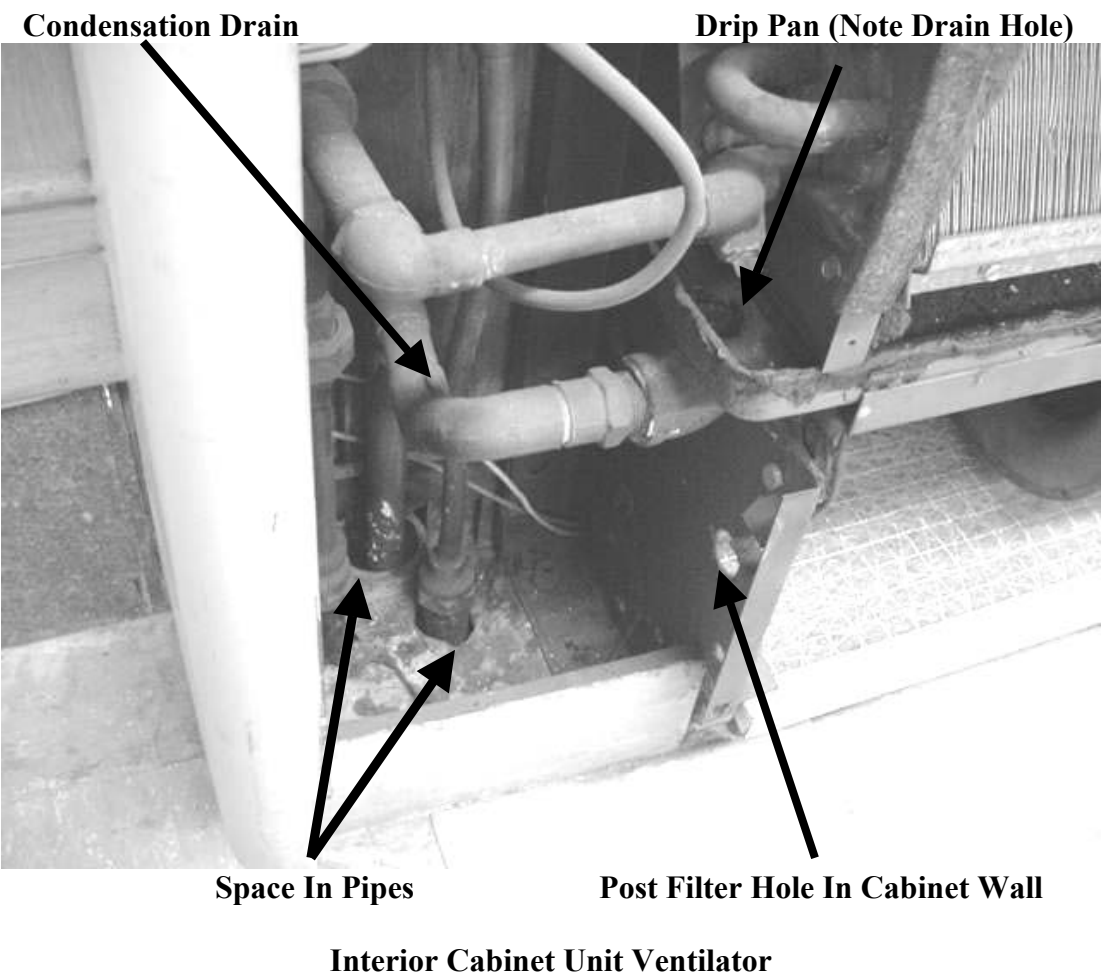
**Picture 15**

Spaces around pipes (see Picture 15) and the back wall (see Picture 16) were noted within all univent cabinet interiors surveyed. Accumulated debris was also observed in univent drip pans (see Picture 17). Note that a hole exists in the interior wall of the univent cabinet post filter. Holes in cabinets and spaces around pipes can serve as pathways for dust, dirt, odors and other pollutants to move from the floor/wall cavities into occupied areas during operation. These materials can be irritating to the eyes, nose and throat.

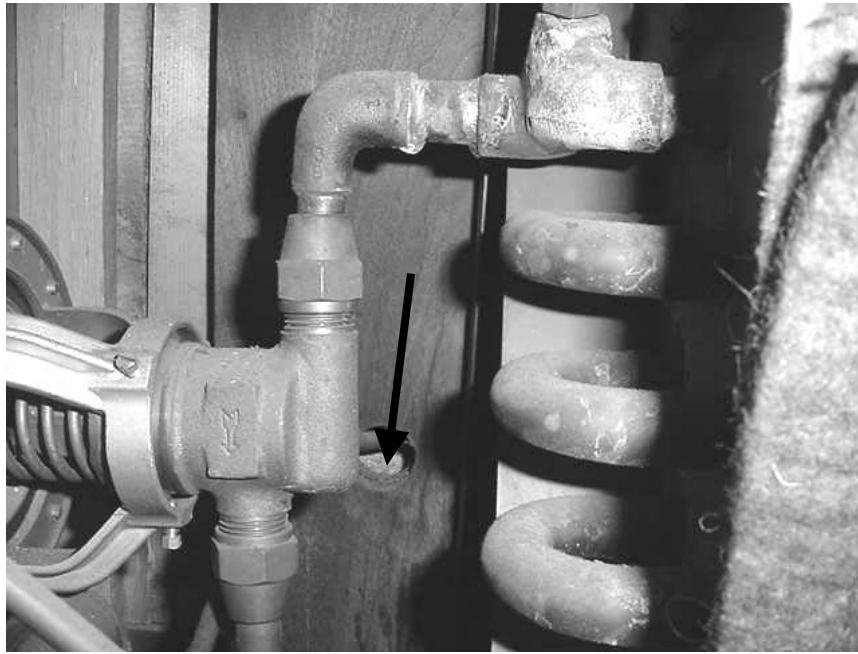
**Picture 16**

**Holes In Rear Wall Of Univent Cabinet**

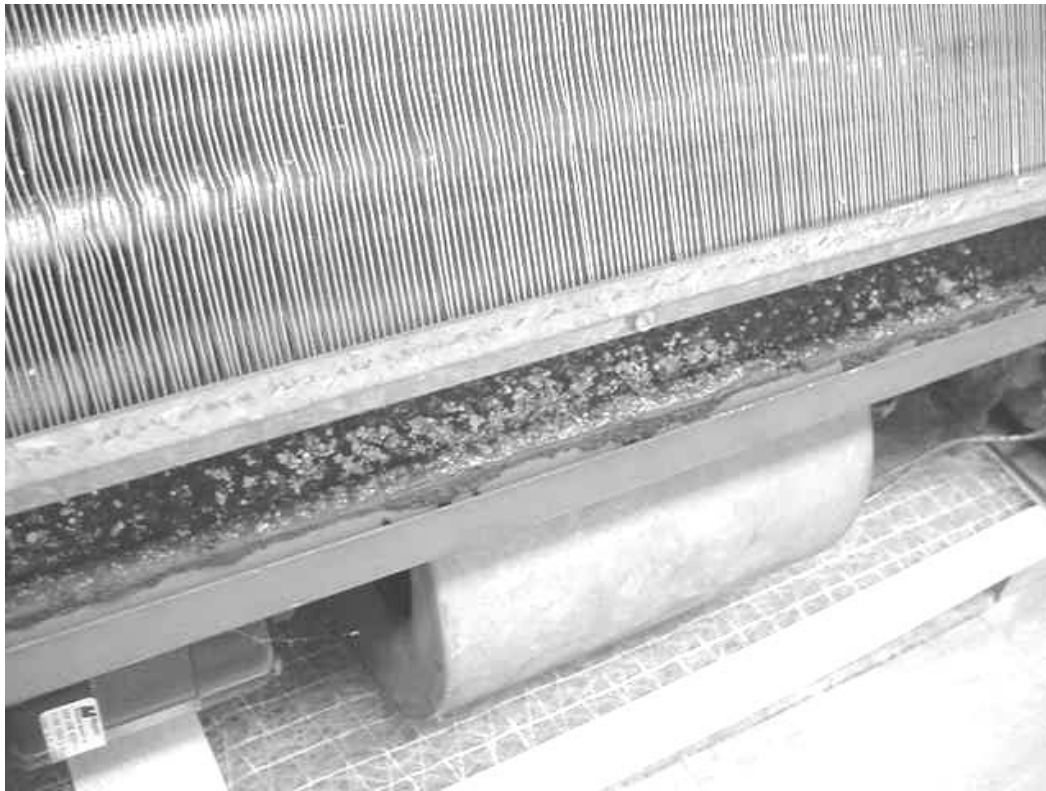
**Picture 17**

**Debris/Mold Growth In Univent Drip Pan**

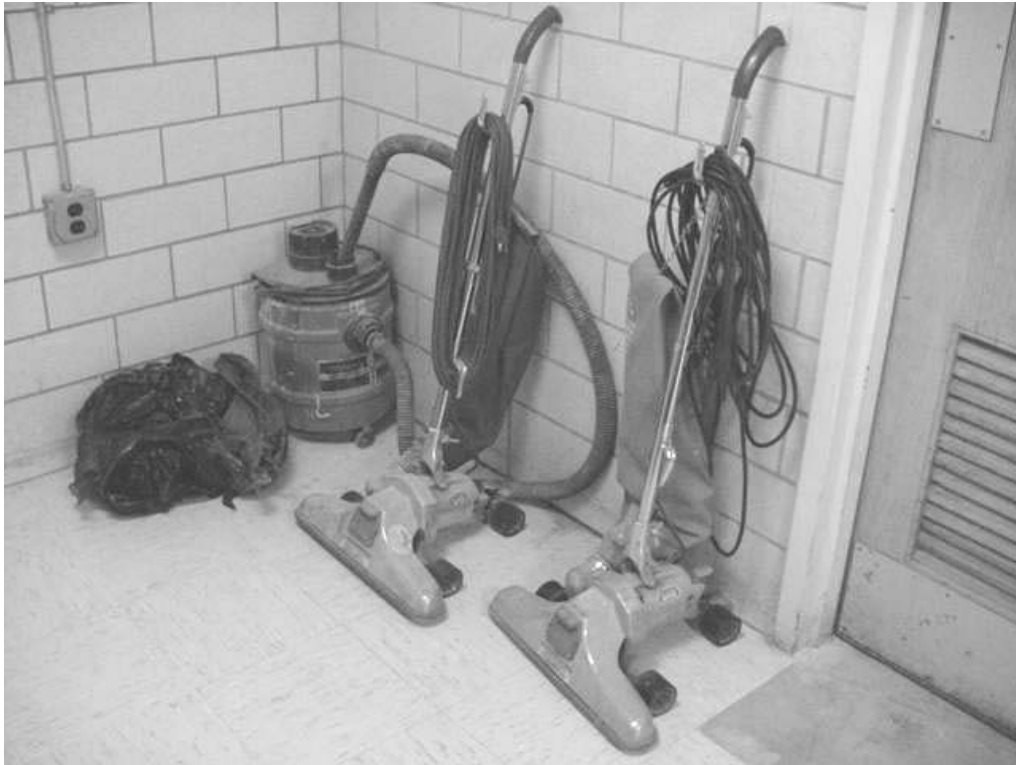
**Picture 18**

**Vacuum Cleaning Equipment Used At The SDC**

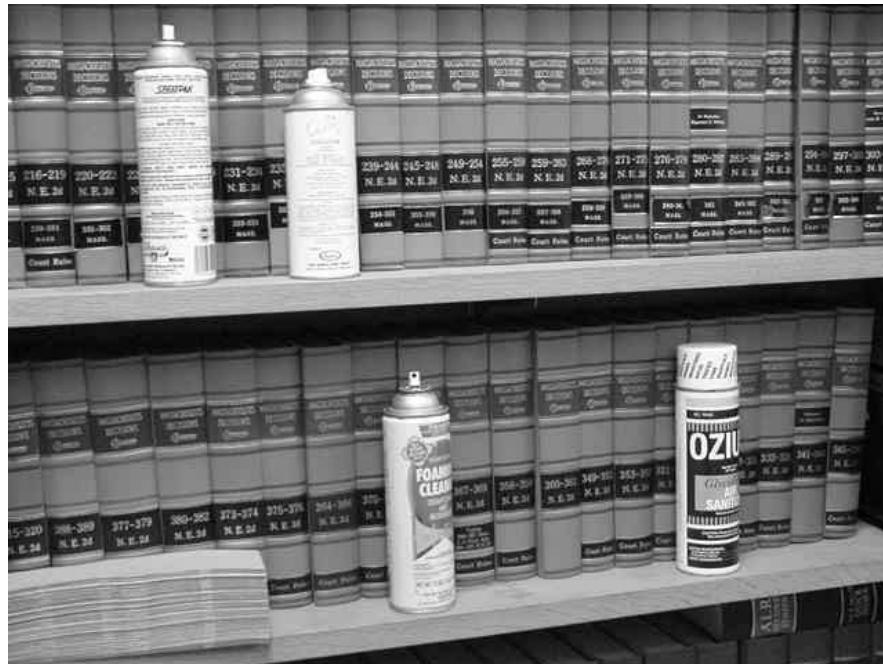
Picture 19

Lastly, SDC staff frequently use a number of spray materials (see Pictures 19 & 19A) to clean work areas. These materials contain VOCs that can be irritating to the eyes, nose and throat. The conditions above, in combination with those discussed earlier, (e.g., inactive ventilation systems, non-HEPA vacuum cleaners in use) considered individually present conditions that could degrade indoor air quality. When combined, these conditions can serve to exacerbate conditions leading to eye irritations and other indoor air quality comfort complaints.

VOC-Containing Spray Cleaners

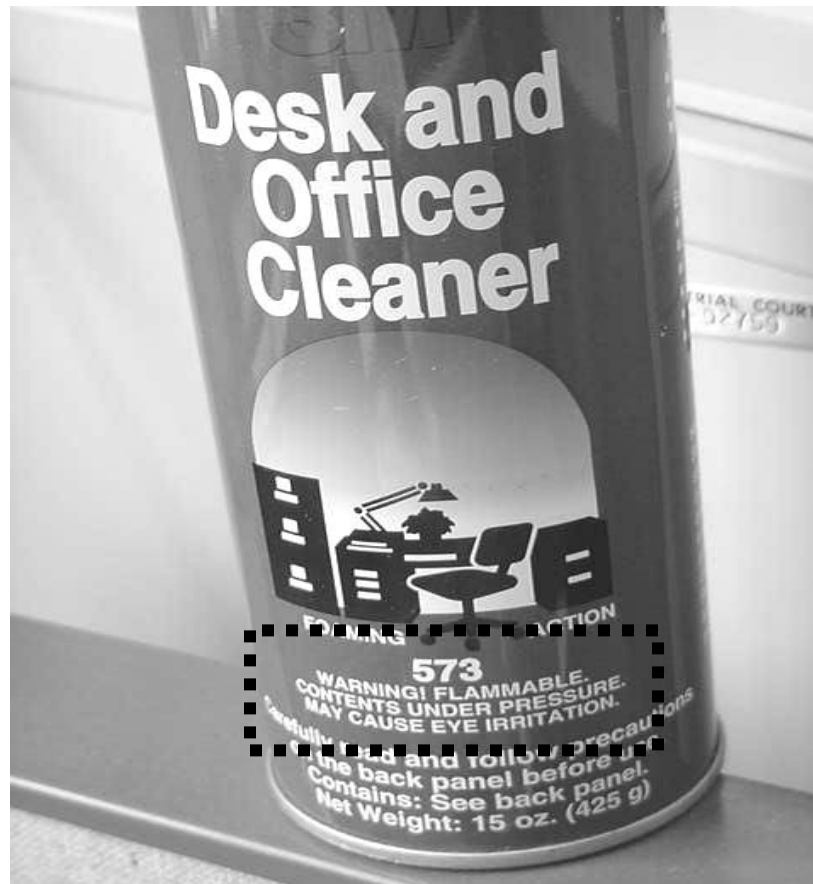
Picture 19A

VOC-Containing Spray Cleaners, Note Warning Label
